PLASTIC PIER PILING EVALUATION REPORT

Navy Region Southwest

Navy Environmental Leadership Program

Tetra Tech EM Inc.
591 Camino De La Reina, Suite 640
San Diego, California 92108

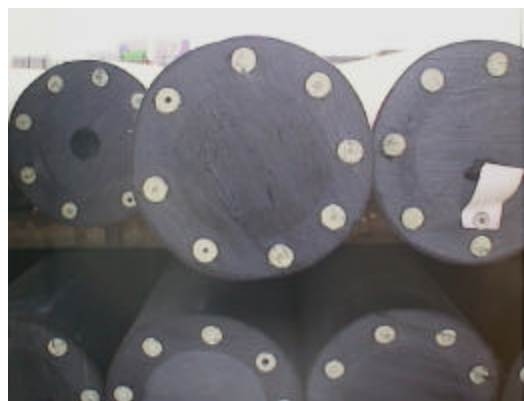
Fiberglass-reinforced plastic pilings consist of an outer skin of dense plastic and an inner core of foamed plastic encapsulating reinforcing fiberglass elements

Ends of Fiberglass-Reinforced Plastic Pier Pilings

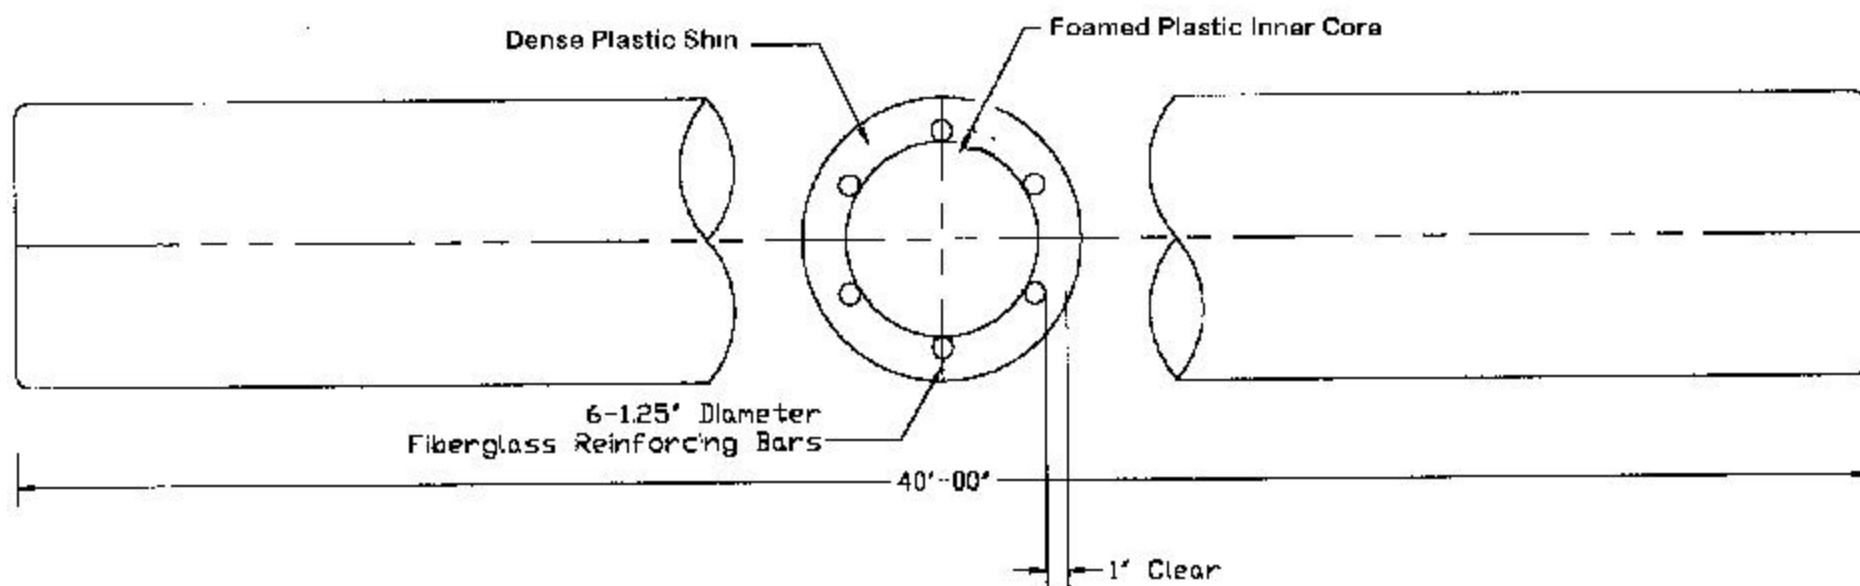
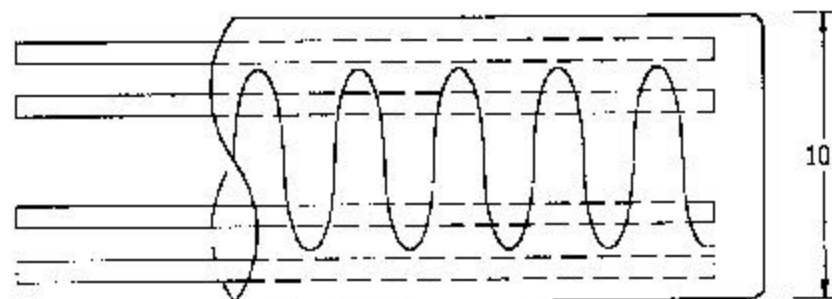
Unit Weight	CATALOG NO.
2120 lbs	PP-10P#10

DESCRIPTION
10" Diameter x 40' Piling
w/ Fiberglass Cage Reinforcement

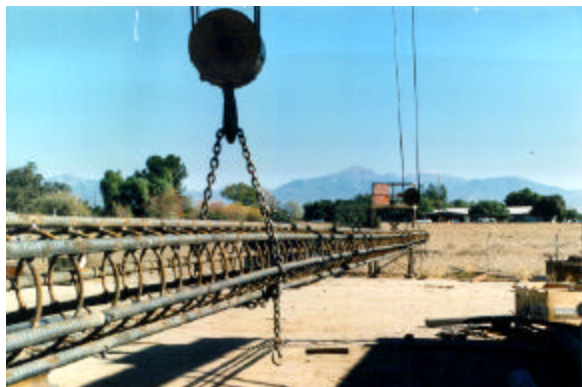
Two types of steel-reinforced plastic pilings are available: (1) steel pipe core-reinforced plastic piling (see Figure 2), and (2) welded steel-cage-reinforced plastic piling (see Figure 3). The steel-reinforced plastic pilings consist of an outer skin of dense plastic and an inner core of foamed plastic encapsulating the

Welded steel-cage-reinforced plastic pier piling

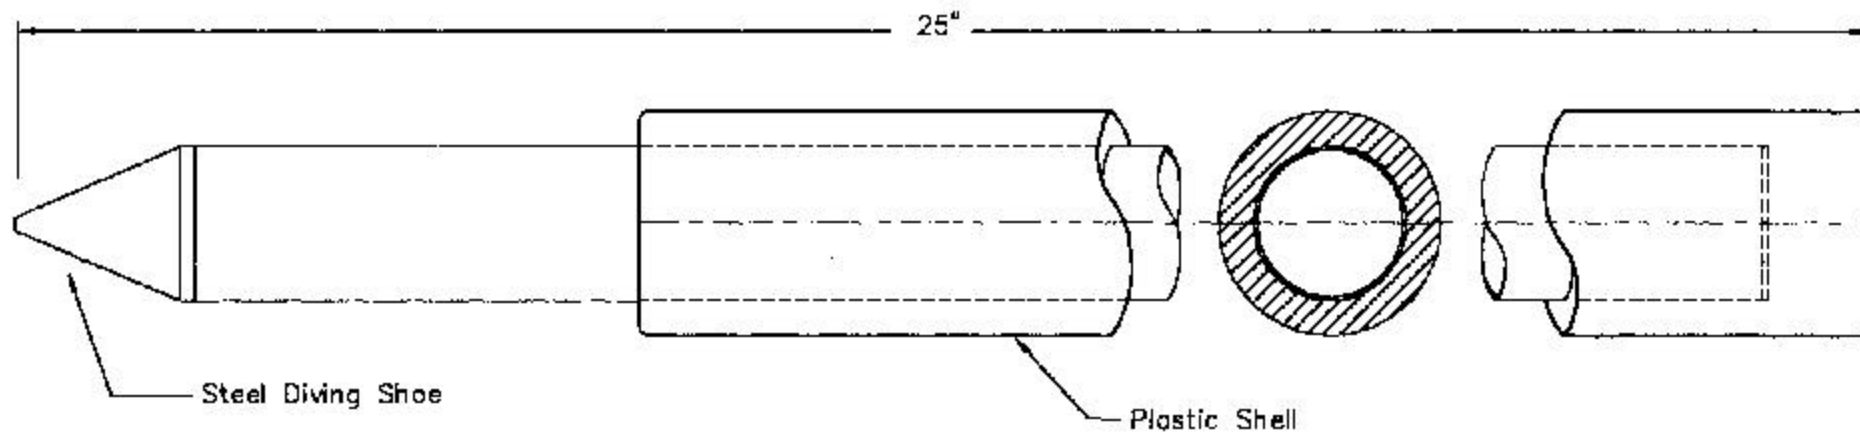
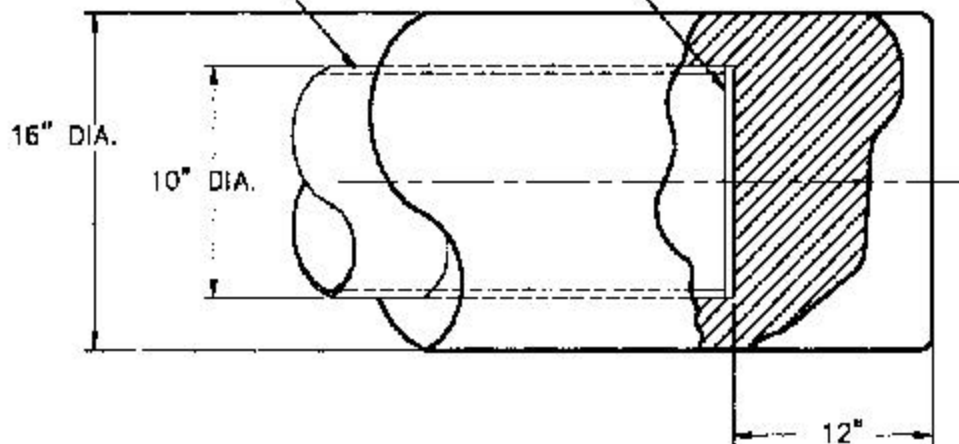
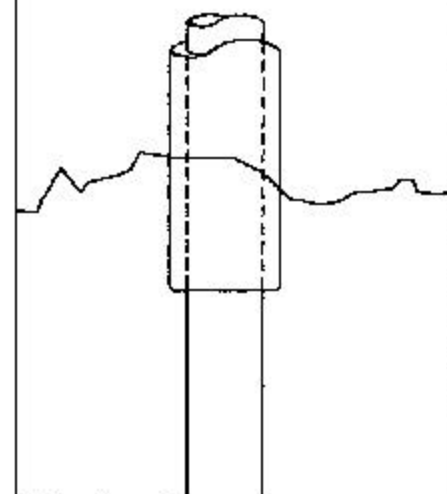
Unit Weight	CATALOG NO.
2325 lbs	PPI16P10

Sch 60 Steel Pipe Core
with Steel End Plate

Plastic to Penetrate
Mud Line Min. 5'

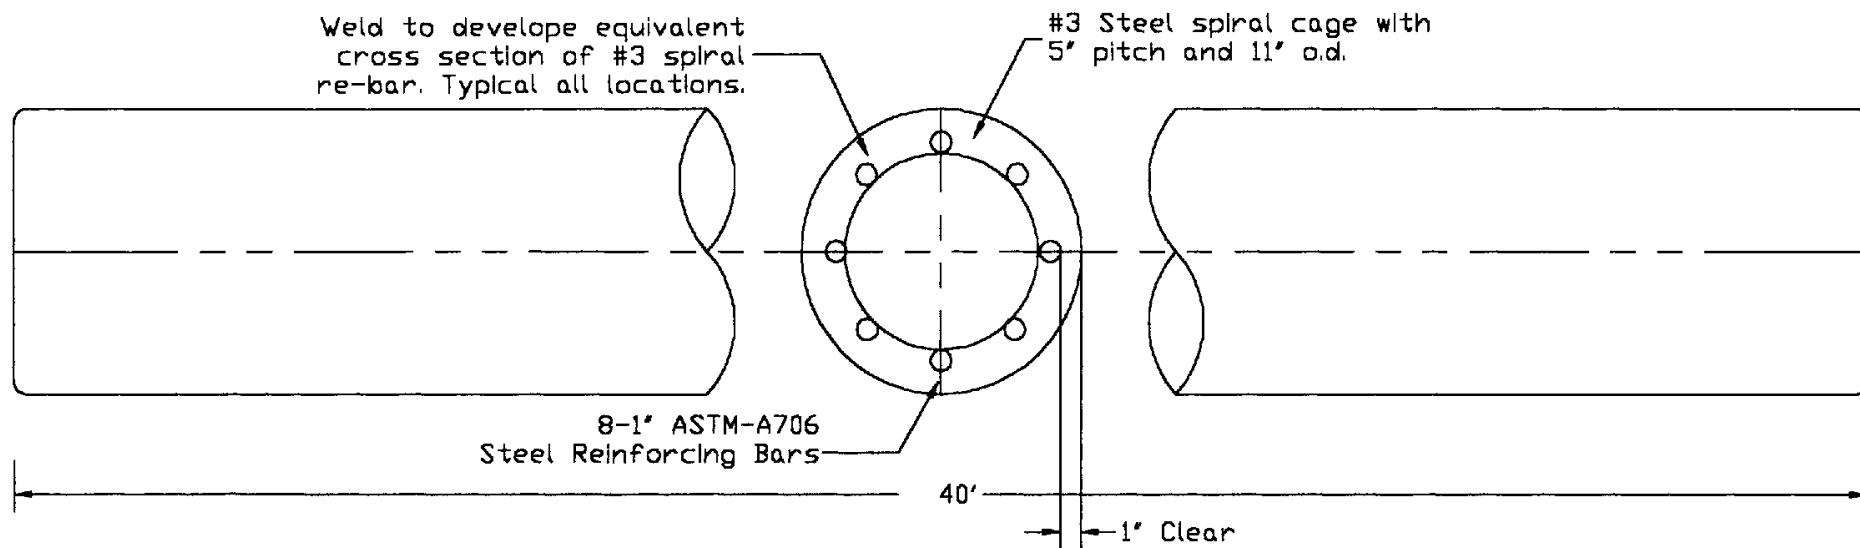
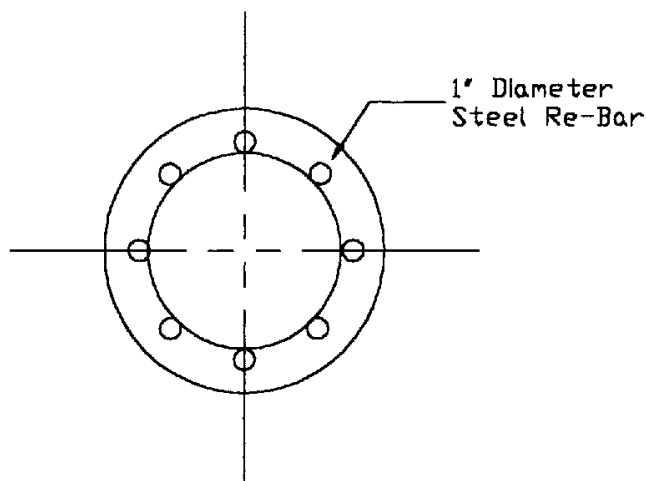
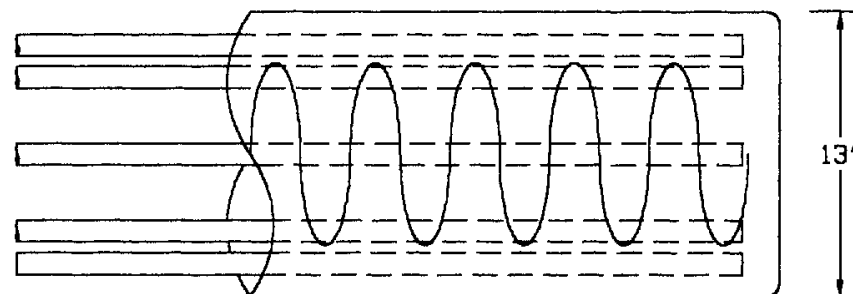
Unit Weight	CATALOG NO.
2520	PPI13P#8

DESCRIPTION
13" Diameter x 40' Pilings w/ Steel Cage Reinforcement Pier 160 Spawar USN San Diego, Ca.

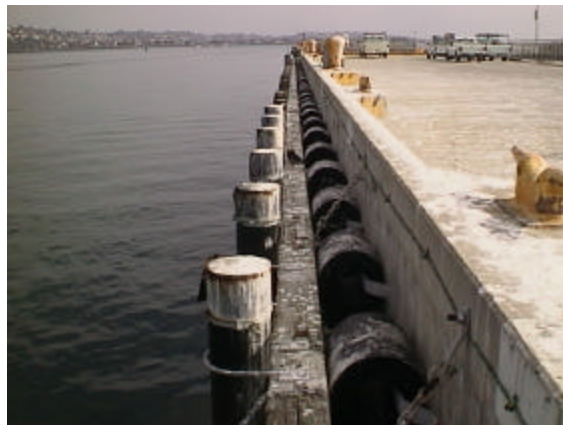
water surface. During the second inspection of the pilings, heavy accumulations of barnacles, mussels, and marine algae were observed on the plastic pier pilings, with the heaviest accumulation

occurring in the tidal zone. Abrasions were also observed on the plastic pier pilings where the wood camel rubbed along the front of the piles. However, timber fender piles observed in the immediate vicinity of the plastic pier piling showed significantly more wear and abrasion than the plastic pier pilings, likely due to the

PPI Plastic Pier Pilings Installed at Pier Bravo

During the July 1999 inspection, the two northern-most plastic pier pilings appeared to be permanently deformed. Both pilings were bent about half way between the top of the piling and the water surface with maximum deflection of about 1 foot inwards, towards the pier. At the time of the inspection, only eight of the plastic pier pilings were protected by a camel; the four northern-most plastic pier pilings, including the two deformed piles, were unprotected. The likely cause of the deformation was the loading of the plastic pier piling beyond its elastic limit from the impact of a berthing ship. It is likely that without the protection of a camel riding out in front of the two pilings, a berthing ship directly hit the fender pilings. According to Joseph Shelton, Pier Maintenance Manager, no documentation of the event was recorded. Although the two piles are permanently deformed, they still appear to be functional and showed no other visual signs of damage. Several timber fender piles in the immediate vicinity of the plastic pier pilings also showed indications of ship damage such as scour marks and scrapes as well as cracked and broken piles.

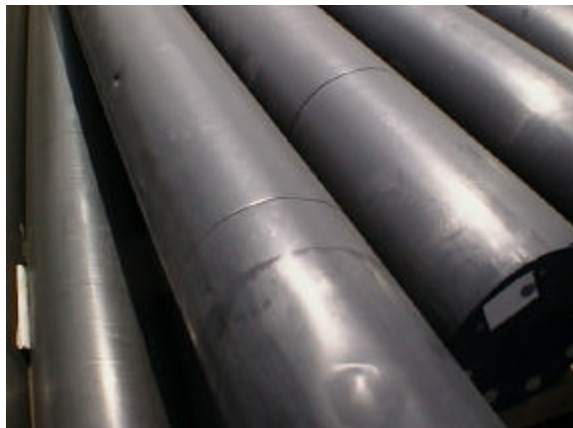
The fender pilings at NAVSTA are periodically inspected by PWC. Typically, fender pilings are only inspected when they have sustained damage or need replacement. However, in July and August 1998, PWC conducted an inspection of more than 300 plastic pier pilings at NAVSTA because of a structural concern over the presence of transverse cracks in the outer matrix of many of the fiberglass-reinforced plastic pier pilings. Of the more than 300 plastic pier pilings inspected, 87 exhibited transverse cracks perpendicular to the long axis of the piling. According to Seaward, the transverse cracks were caused by a defect in the manufacturer's process, which has since been corrected. To evaluate the structural integrity of the cracked piles, Lehigh University's Fritz Engineering Laboratory conducted a flexural test on the cracked piles. According to the structural report prepared by Lehigh University, the data indicated that the cracked pile exhibited "no significant difference in pile deflection or stiffness" when compared to uncracked pilings (Lehigh 1995). The study further suggests that the matrix cracks on the have

Stockpiled Cracked Pilings

no measurable influence on the overall flexural behavior of the piling. Although the manufacturer claims that the structural integrity of the fiberglass-reinforced pilings is not adversely impacted, they have offered to replace the cracked pilings.

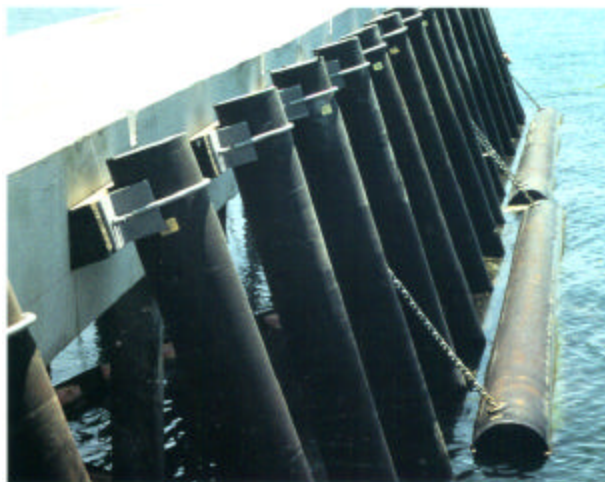
Naval Amphibious Bases Coronado. Steel-reinforced plastic pier pilings manufactured by PPI were installed at Pier 16 at NAB Coronado in May 1996. Pier 16 is a small finger pier, and the fender pilings installed were designed for barge loads. To sustain barge loads, 16-inch-diameter plastic pier pilings with 10-inch-diameter, schedule 60 steel pipe core were used. Twenty four-inch diameter camels also manufactured by PPI from recycled plastic were also installed along the fender piles. Reportedly, ship berthing at the pier is infrequent and the pilings have a low potential to sustain ship damage. According to Vergil McCallaster, the NAB Coronado Facilities Manager, the plastic pier pilings are still in excellent condition, while many of the untreated timber piles at NAB Coronado installed around the same time have required replacement. Mr. McCallaster indicated that ACZA-treated timber pilings had also been installed within the last year at several of the piers at NAB Coronado. However, the condition of these treated pilings was not evaluated during this study.

Steel-Reinforced Plastic Pier Pilings Installed at NAB Coronado Pier 16
